Watershed Emergency Response Team Evaluation SCU LIGHTNING COMPLEX

CA-SCU-005740

September 21, 2020

WATERSHED EMERGENCY RESPONSE TEAM EVALUATION

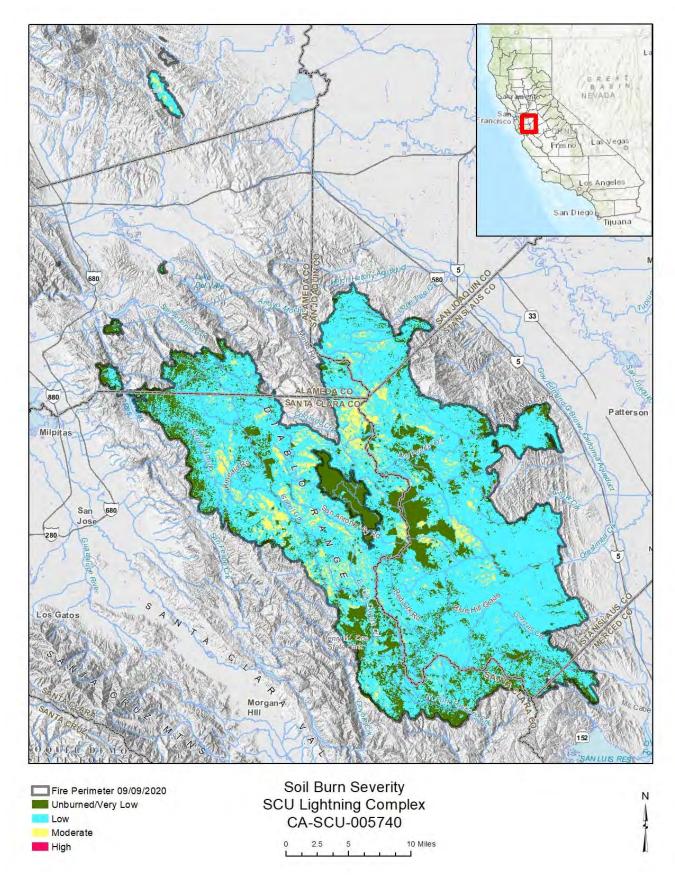
Figure 9. Soil burn severity map for the SCU Lightning Complex.

The WERT found the observed soil burn severity was generally lower than the BARC map classification for moderate and high burn severities. A CAL FIRE watershed scientist/GIS analyst adjusted the BARC map to match observed soil burn severity and vegetation type to produce a SBS map. The USGS Landslide Hazards Program used the SBS map as one input for the USGS post-wildfire debris flow hazard model (Figure 9).

The SCU Lightning Complex burned area is dominated by unburned/very low and low soil burn severity (Figure 9) (Table 3). Over 92% of the fire area burned at low severity or less. Soil burn severity was limited because of the type of fuels present (chaparral, oak woodland with grass understory, and grassland) and the rate of fire spread. The denser the vegetative cover and the slower the rate of fire spread typically results in higher soil burn severity.

Based on the soil burn severity map, some of the slopes on the west-central portions of the SCU Lightning Complex that drain north towards Livermore and Pleasanton experienced moderate soil burn severity within larger areas of low soil burn severity. An area of steep slopes on the North Fork of Orestimba Creek burned at moderate SBS. Additionally, small, isolated areas of the North Fork of Pacheco Creek burned at moderate SBS.

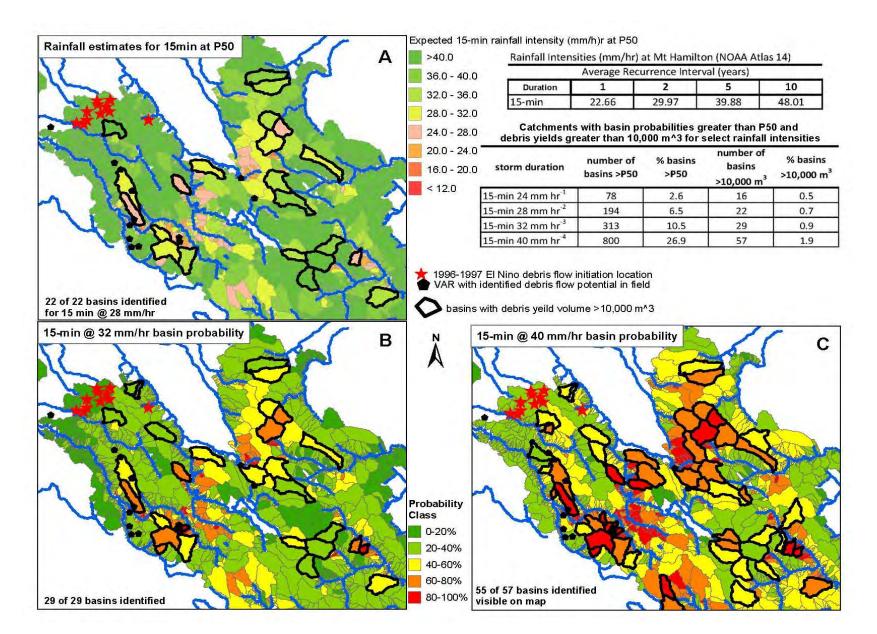
The locations of historical debris flows initiated during the winter of 1996-1997 are plotted on Figure 11a. They are clustered in the northwestern corner of the SCU Lightning Complex burned area. Figure 11a, panel A illustrates that basins underlying the 1997 debris flow locations require a greater than 40 mmhr⁻¹ rainfall intensity for the 15-minute duration event for a P50 probability to generate debris flows. The clustering of the 1996-1997 debris flow locations to the northern portions of the burned area could be a result of a combination of rain shadow effect over the southern burned area and the debris flows that initiated were in an unburned condition and also likely initiated under different storm conditions than considered by the USGS Post-Fire Debris Flow Hazard Model.
