Watershed Emergency Response Team Evaluation SCU LIGHTNING COMPLEX

CA-SCU-005740

September 21, 2020

WATERSHED EMERGENCY RESPONSE TEAM EVALUATION

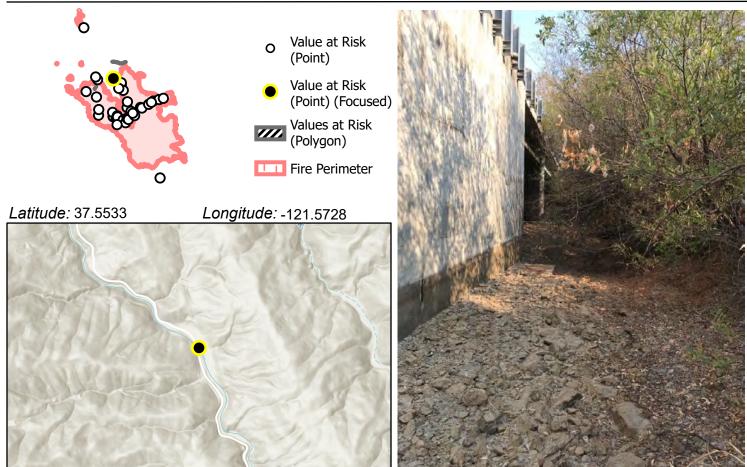
Field Observation Large bridge crossing on Arroyo Macho at oblique angle, forcing a bend in the *or Potential Hazard:* creek. Creek confined upstream of crossing and widens at bend in crossing. Aggredation under bridge. Abundant vegetation in channel above and below crossing.

Potential Hazard to Life: **low**

Potential Hazard to Property: moderate

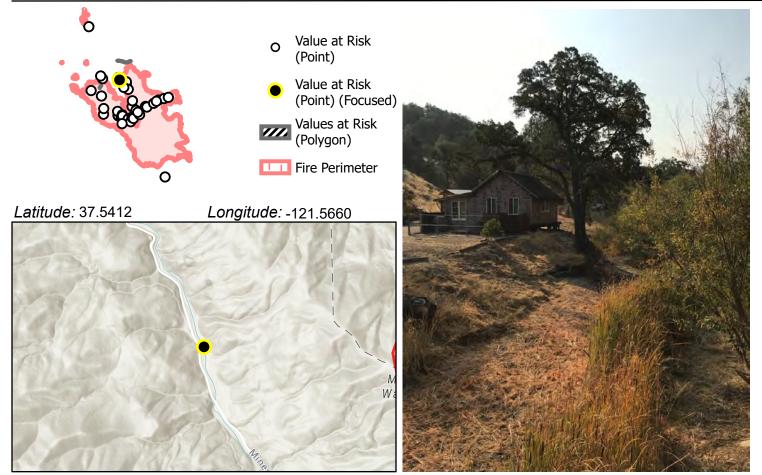
Field Observation House situated on terrace above creek downstream of burn area. Slight bend in *or Potential Hazard:* creek upstream from structure, could cause erosion and flooding issues. Lower terrace noted on other side of stream.

Potential Hazard to Life: low

Potential Hazard to Property: moderate

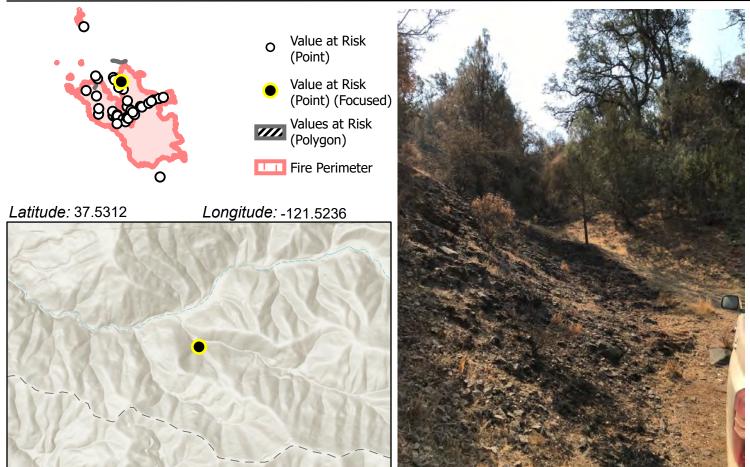
Field Observation Home situated at mouth of 2 steep sidehill drainages. Owners say one of the *or Potential Hazard:* drainages flows in the winter, but goes down driveway, which is very close to house.

Potential Hazard to Life: low

Potential Hazard to Property: moderate

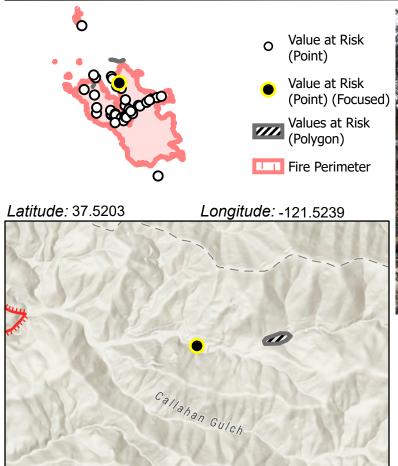
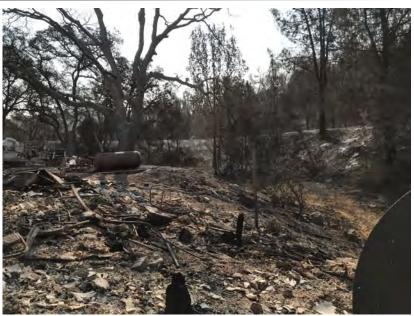
Field Observation Home situated above channel in floodplain. However, a stock pond *or Potential Hazard:* impoundment is just upstream from house across creek. Unclear where creek drains through. Possible diversion channel on north side of property.

Potential Hazard to Life: low

Potential Hazard to Property: moderate

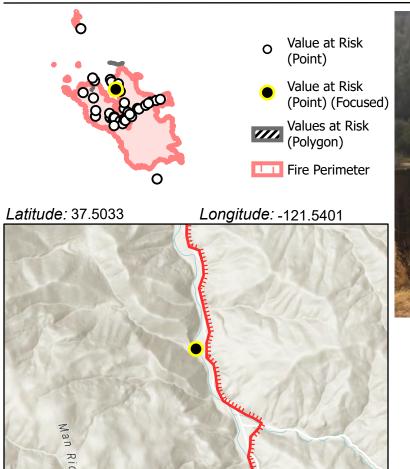
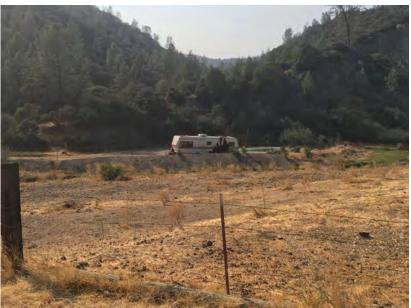
Field Observation RV on building pad 5 ft above stream channel *or Potential Hazard:*

Potential Hazard to Life: **low**

Potential Hazard to Property: moderate

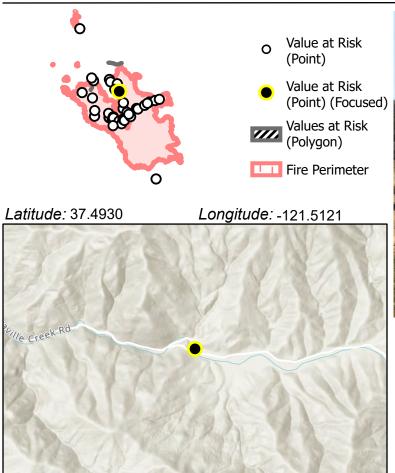
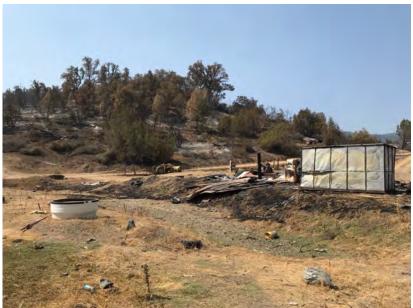
Field Observation Burned structure located adjacent to channel on old fan. Upstream culvert looks *or Potential Hazard:* new, indicating possible prior issues at sites. Sharp bend in main channel near structure could cause flood waters could jump out of channel during flood and impact structure.

Potential Hazard to Life: low

Potential Hazard to Property: moderate

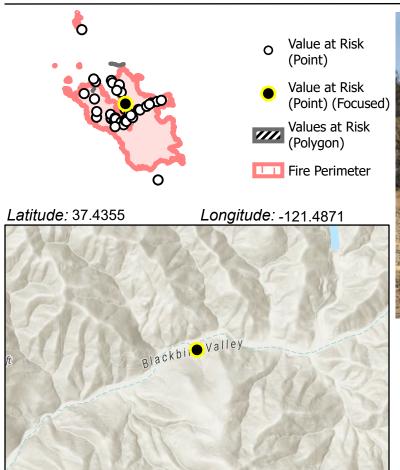
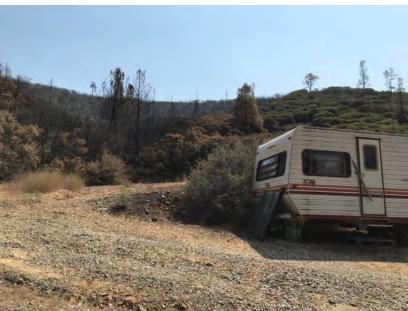
Field Observation Several mobile homes located at mouth of drainage. Erosion/rilling present on *or Potential Hazard:* driveway from prior flow out of catchment.

Potential Hazard to Life: low

Potential Hazard to Property: moderate

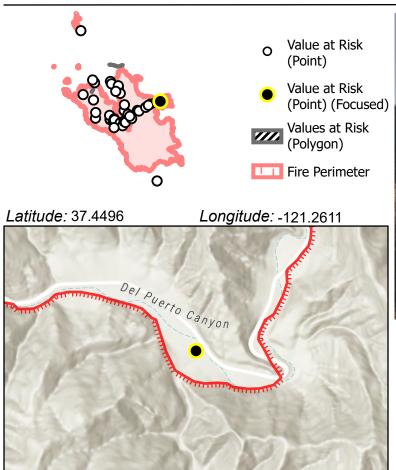
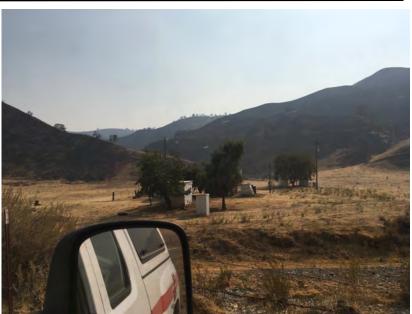
Field Observation House and ranch buildings in flood plain *or Potential Hazard:*

Potential Hazard to Life: low

Potential Hazard to Property: moderate

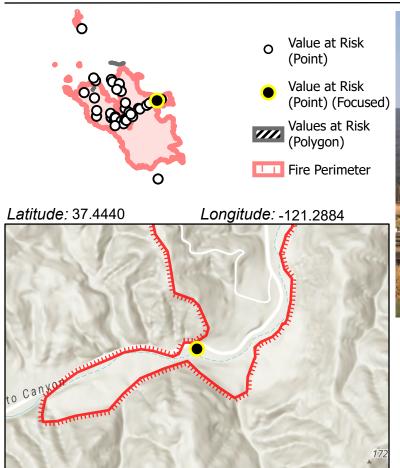
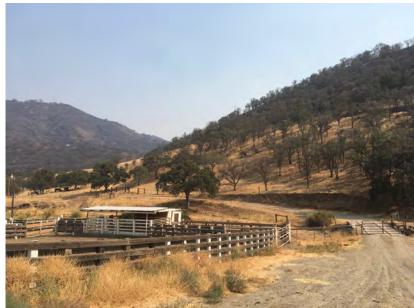
Field Observation House and ranch structures in flood plain *or Potential Hazard:*

Potential Hazard to Life: **low**

Potential Hazard to Property: moderate

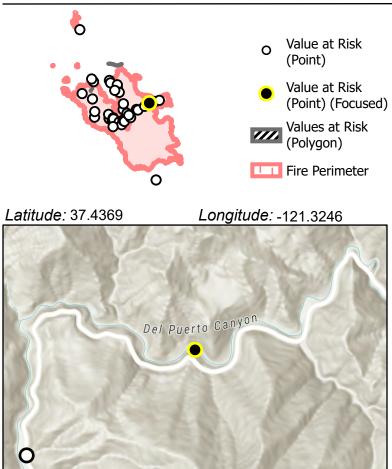
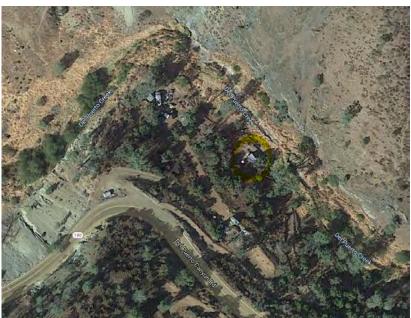
Field Observation Structure on low lying surface near channel, possible residence. Could not *or Potential Hazard:* access.

Potential Hazard to Life: low

Potential Hazard to Property: moderate

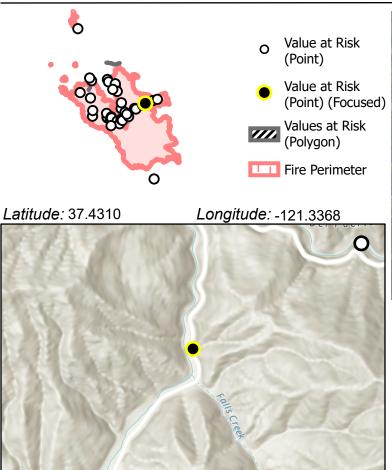
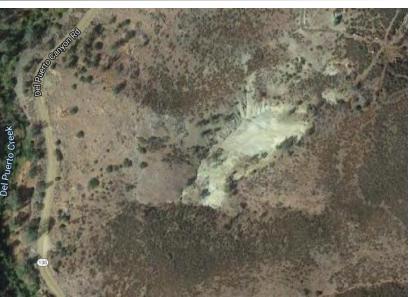
Field Observation Debris slide potential onto road. Low burn severity. *or Potential Hazard:*

Potential Hazard to Life: **low**

Potential Hazard to Property: moderate

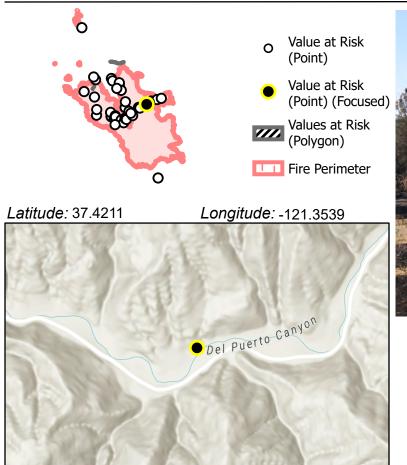
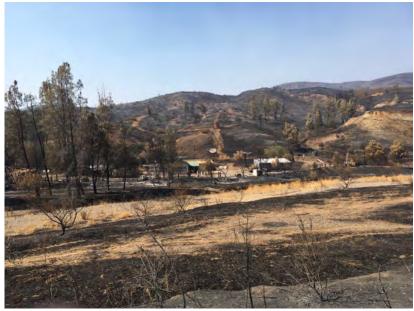
Field Observation House and ranch buildings in flood plain *or Potential Hazard:*

Potential Hazard to Life: **low**

Potential Hazard to Property: moderate

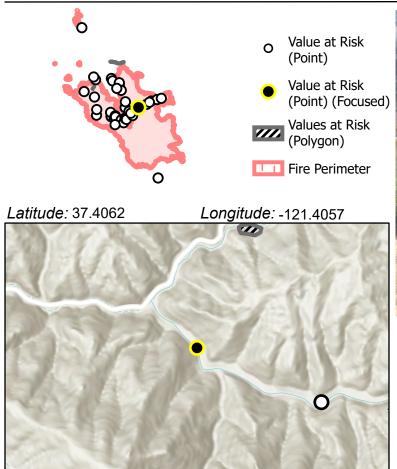
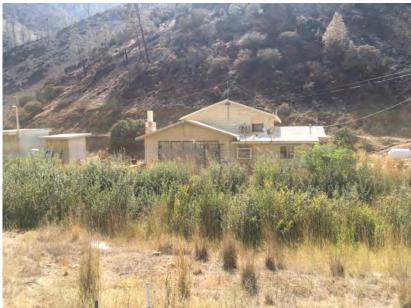
Field Observation House on low lying surface near channel *or Potential Hazard*:

Potential Hazard to Life: **low**

Potential Hazard to Property: moderate

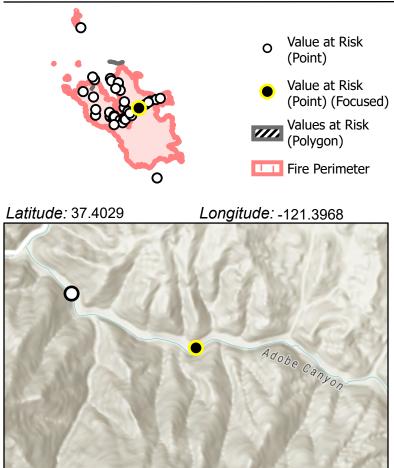
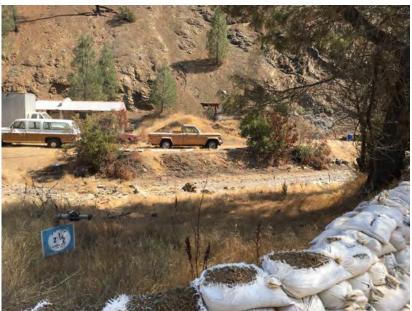
Field Observation Residential structure and chemical storage infrastructure near channel. Longor *Potential Hazard*: time resident said water has never come above the channel banks.

Potential Hazard to Life: low

Potential Hazard to Property: moderate

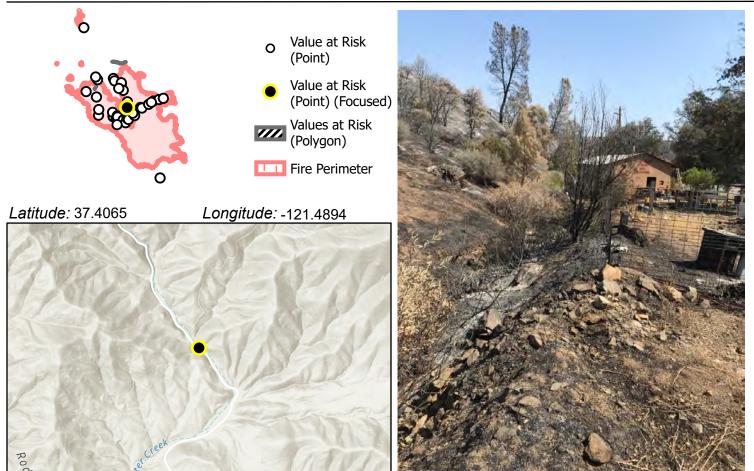
Field Observation Business, outbuilding on low surface next to creek. *or Potential Hazard:*

Potential Hazard to Life: **low**

Potential Hazard to Property: moderate

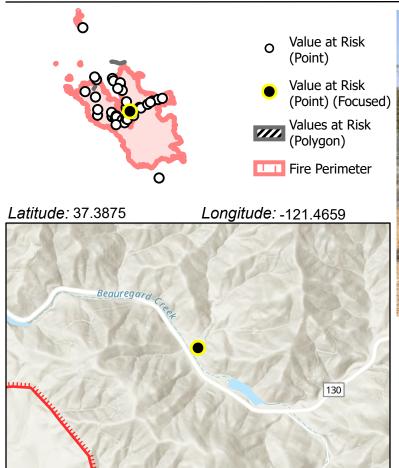
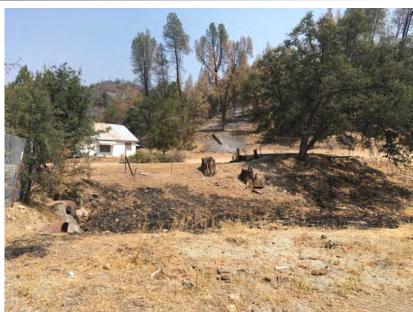
Field Observation House on a terrace near the channel. Two large culverts under driveway across *or Potential Hazard*: channel have the potential to clog.

Potential Hazard to Life: low

Potential Hazard to Property: moderate

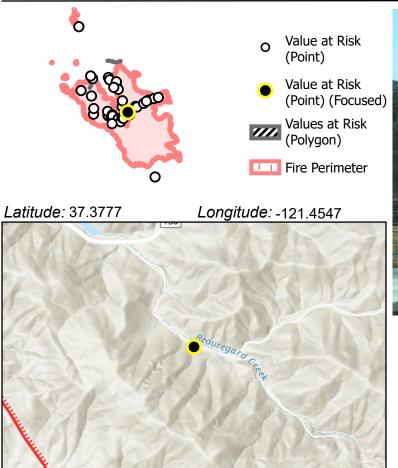
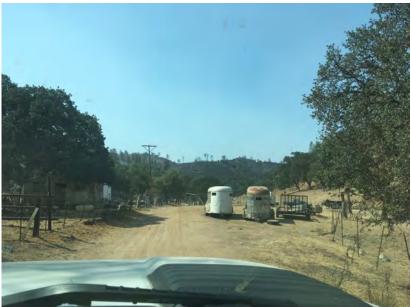
Field Observation Trailers and ranch buildings on low lying surface near channel *or Potential Hazard:*

Potential Hazard to Life: low

Potential Hazard to Property: moderate

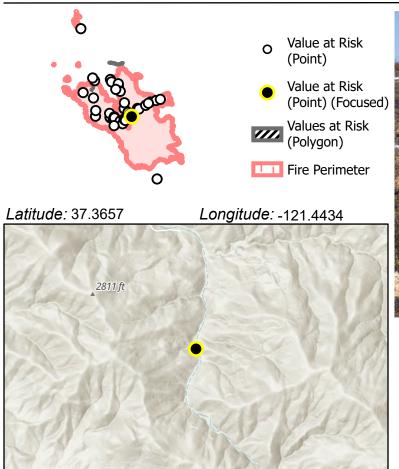
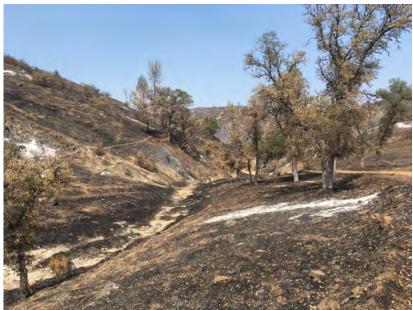
Field Observation House on low lying surface near a channel *or Potential Hazard:*

Potential Hazard to Life: moderate

Potential Hazard to Property: moderate

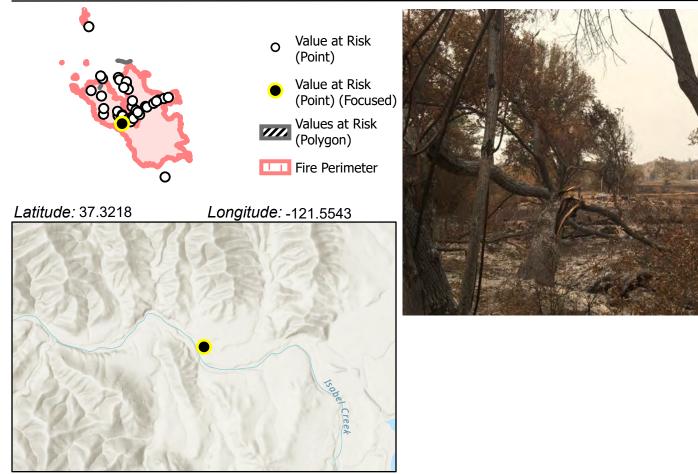
Field Observation Destroyed residential structure in flood plain, not much higher than active or *Potential Hazard*: channel

Potential Hazard to Life: moderate

Potential Hazard to Property: moderate

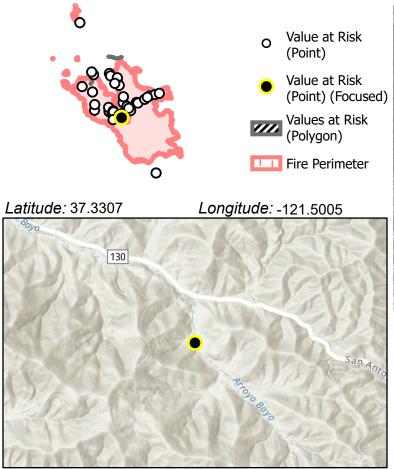
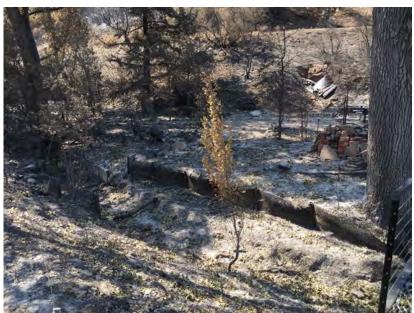
Field Observation Destroyed house near channel. Shed and excavator nearby *or Potential Hazard:*

Potential Hazard to Life: **low**

Potential Hazard to Property: moderate

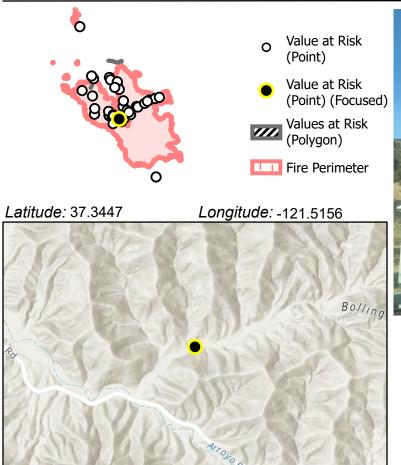
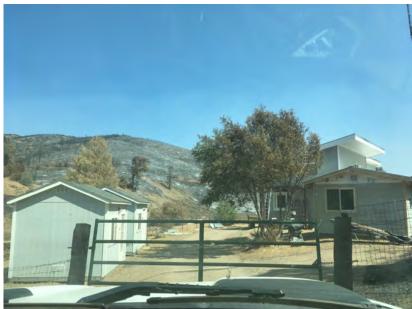
Field Observation House in potential flood plain, on low lying surface near channel *or Potential Hazard:*

Potential Hazard to Life: low

Potential Hazard to Property: moderate

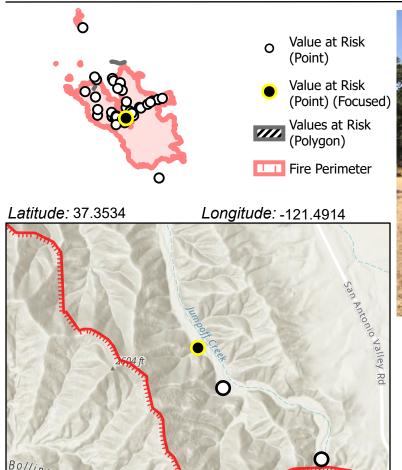
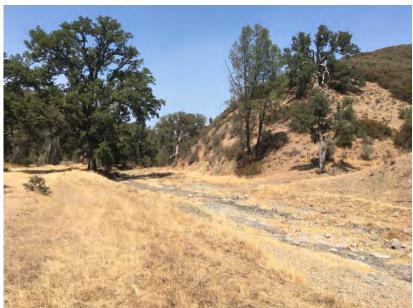
Field Observation House on low lying surface near channel *or Potential Hazard:*

Potential Hazard to Life: **low**

Potential Hazard to Property: moderate

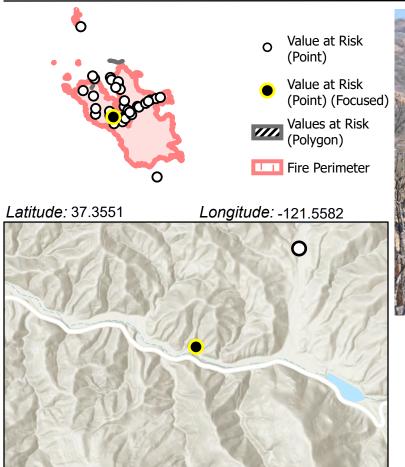
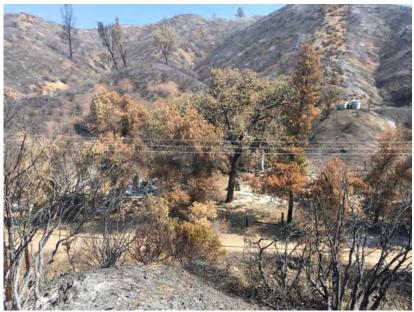
Field Observation Destroyed house in flood plain *or Potential Hazard:*

Potential Hazard to Life: **low**

Potential Hazard to Property: moderate

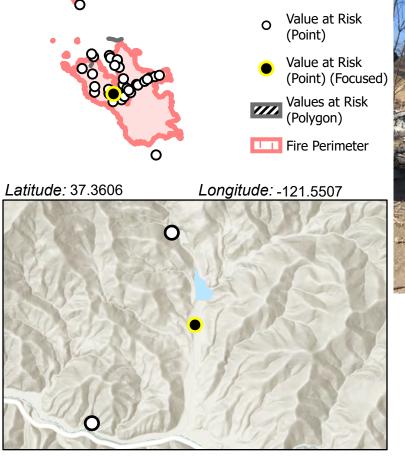
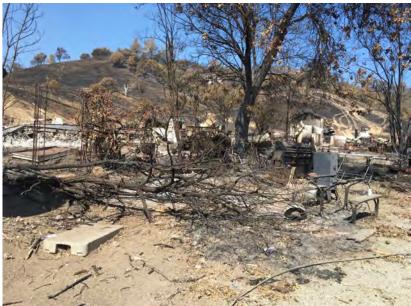
Field Observation Destroyed residential structure and ranch buildings on low lying surface near *or Potential Hazard*: channel. Earthen dams up canyon.

Potential Hazard to Life: low

Potential Hazard to Property: moderate

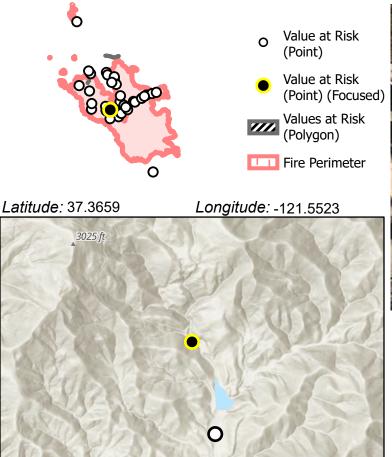
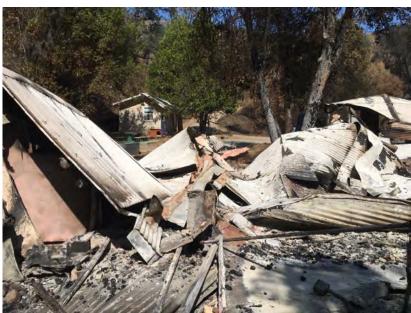
Field Observation Long culvert runs under building pad. Culvert is 60 in, half full of sediment. Has *or Potential Hazard:* elbow in it somewhere under the building pad. If it clogs it could flood house.

Potential Hazard to Life: low

Potential Hazard to Property: moderate

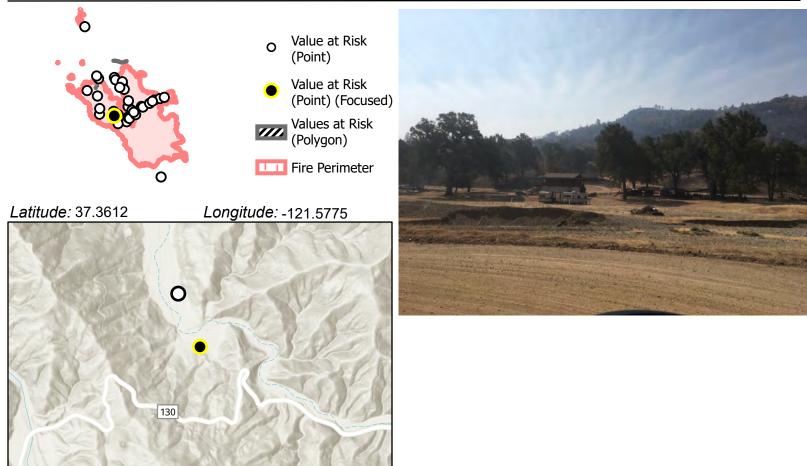
Field Observation Houses, barns, and livestock areas in low lying flood plain. Main house on *or Potential Hazard:* building pad upslope. Talked to homeowner, said they haven't had flood issues in the 30 yrs she's lived there. Trailers near creek are storage only.

Potential Hazard to Life: low

Potential Hazard to Property: moderate

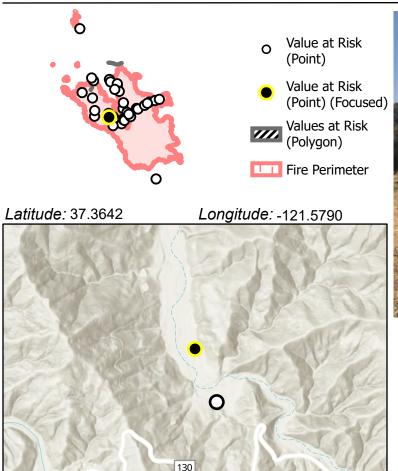
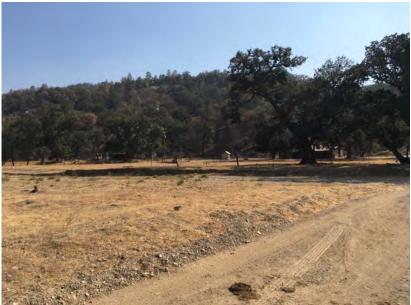
Field Observation House and barn in floodplain *or Potential Hazard:*

Potential Hazard to Life: **low**

Potential Hazard to Property: moderate

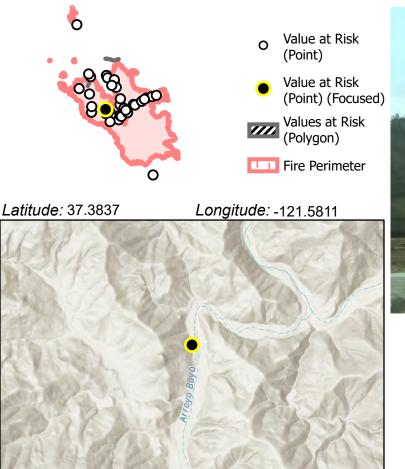
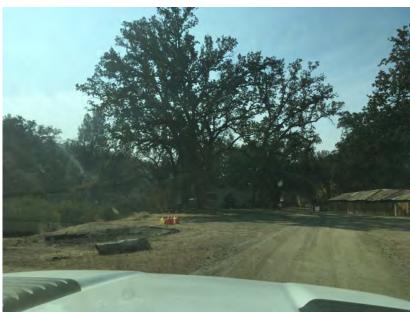
Field Observation Cabins in flood plain or *Potential Hazard:*

Potential Hazard to Life: **low**

Potential Hazard to Property: moderate

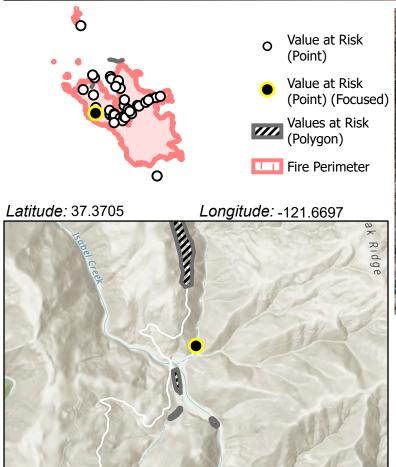
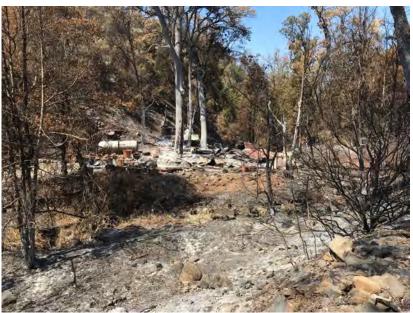
Field Observation Burned structure situated on colluvium adjacent to channel. Large blocky debris or *Potential Hazard*: noted in channel. Possible flood and debris flow hazard.

Potential Hazard to Life: moderate

Potential Hazard to Property: moderate

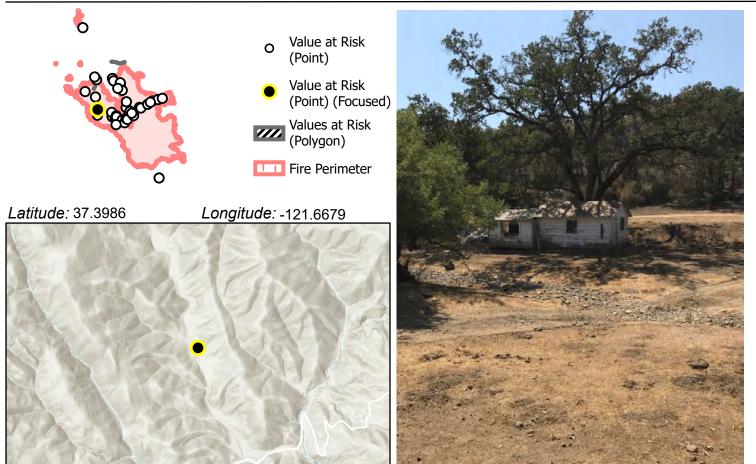
Field Observation Single family home located on floodplain adjacent to channel. *or Potential Hazard:*

Potential Hazard to Life: low

Potential Hazard to Property: moderate

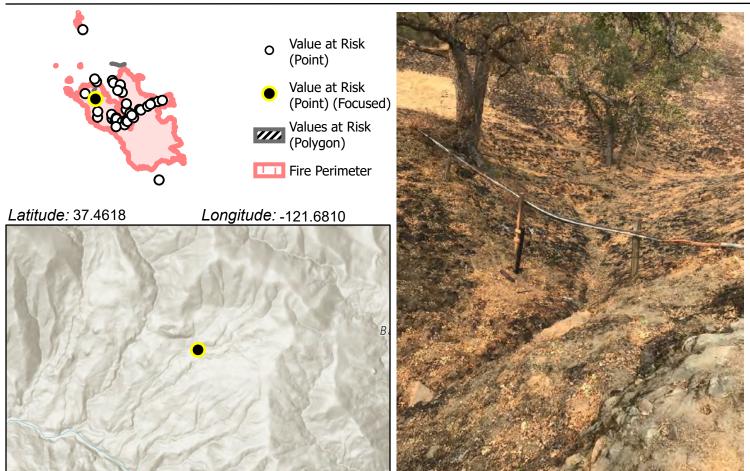
Field Observation Multiple structures located between 2 debris flow channels. Channels are *or Potential Hazard:* incised and have blocky debris in them. Structuresappear to be well above channels, but flows could jump if channels clog. Utility line crosses one of the channels

Potential Hazard to Life: moderate

Potential Hazard to Property: moderate

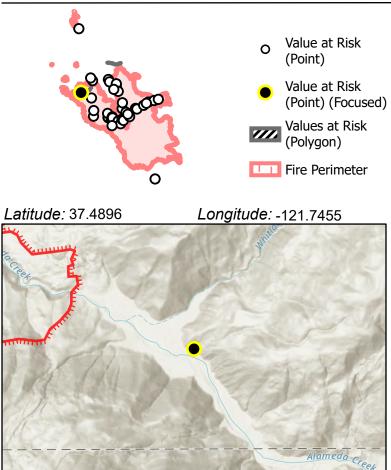
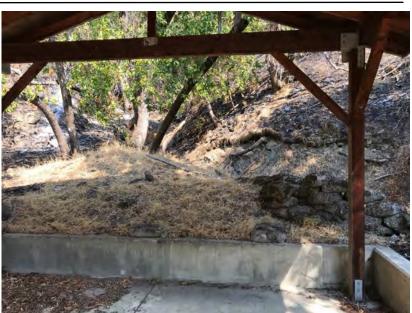
Field Observation Cabin built at mouth of catchment. Debris at mouth of catchment. Deflection *or Potential Hazard:* wall and berm adjacent cabin. Rockfall hazards present too.

Potential Hazard to Life: moderate

Potential Hazard to Property: moderate

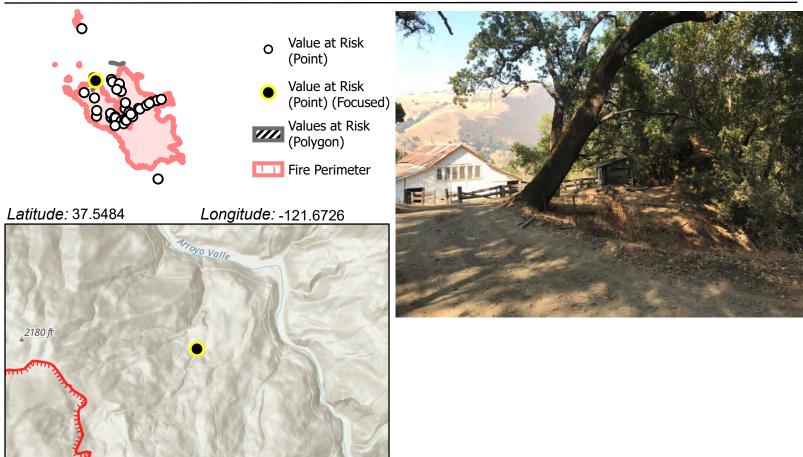
Field Observation Structure situated adjacent to incised channel and downstream from crossing *or Potential Hazard:* that is undersized. Lots of woody debris in channel above crossing. If water flows over crossing, will go down road and into barn.

Potential Hazard to Life: low

Potential Hazard to Property: moderate

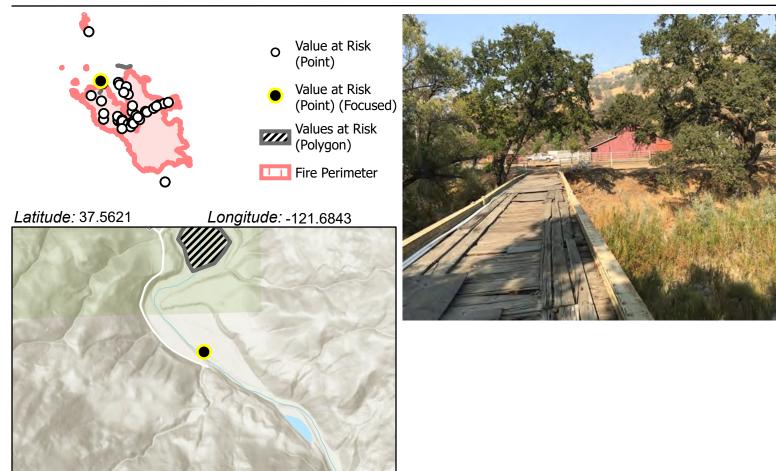
Field Observation Multiple structures located on older flood terrace above channel. Local said *or Potential Hazard:* flood waters reach the bottom of adjacent bridge during bad weather years, which is same elevation as structures, indicating possible flood hazard.

Potential Hazard to Life: low

Potential Hazard to Property: moderate

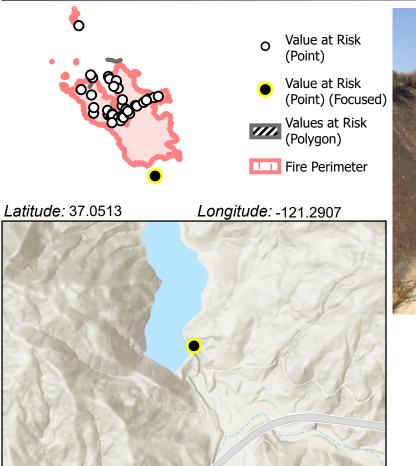
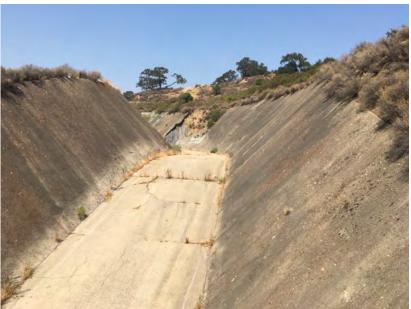
Field Observation Pre-existing damage to spillway from 2017 storm. May be impacted by future *or Potential Hazard:* storm events. Concrete is missing from left wall and bank is eroded.

Potential Hazard to Life: high

Potential Hazard to Property: high

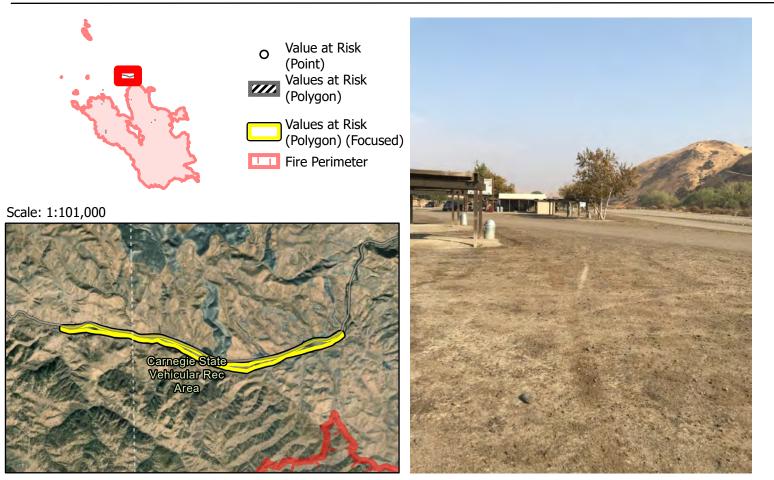
Field Observation Residences, outbuildings, park facilities and County road in FEMA floodplain. *or Potential Hazard:*

Potential Hazard to Life: low

Potential Hazard to Property: moderate

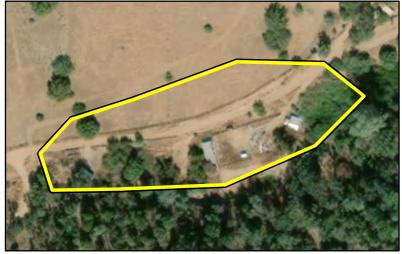
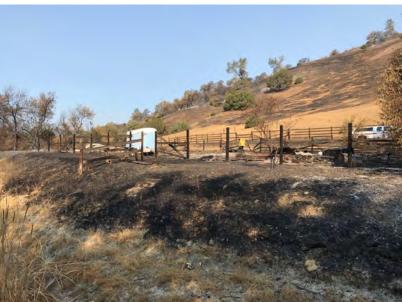
Field Observation Multiple structures located in floodplain adjacent to channel. One structure *or Potential Hazard*: located across channel from steep sidehill drainage.

Potential Hazard to Life: low

Potential Hazard to Property: moderate

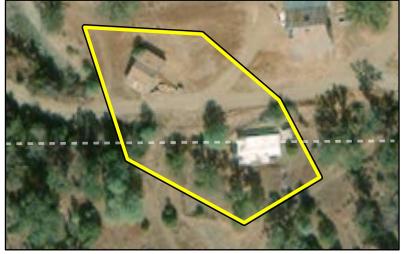
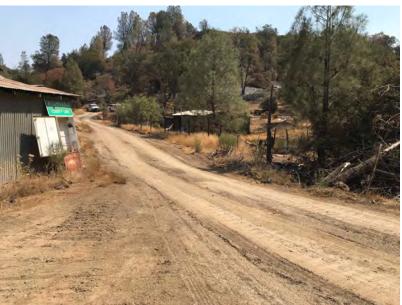
Field Observation Structures located at the mouth of two converging drainages and adjacent to *or Potential Hazard:* stream channel. Two crossings near structures are undersized or have abundant debris in upstream side of channel.

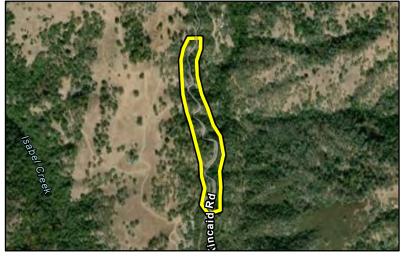
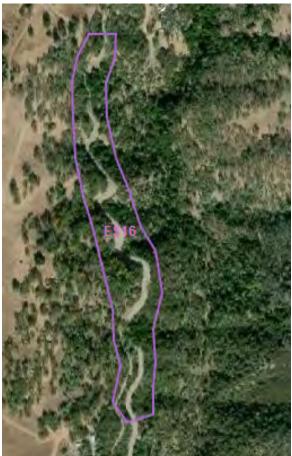
Field Observation Multiple crossings along this stretch of road that are undersized or non-existent. *or Potential Hazard:* Potential for clogging and overtopping. Narrow gullies could pose debris flow hazard risk.

Potential Hazard to Life: low

Potential Hazard to Property: moderate

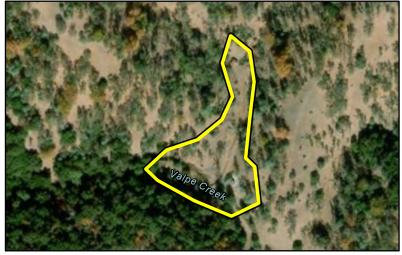
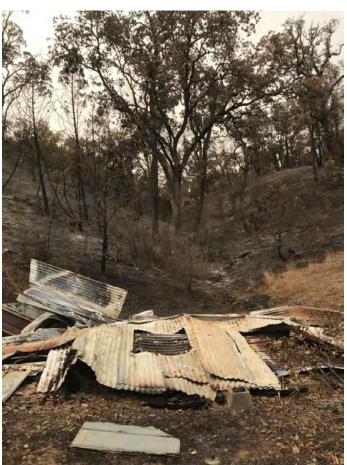
Field Observation Multiple structures located the base of steep drainages. One structure is *or Potential Hazard:* located in a channel, and two others are adjacent to and slightly above main channels. Blocky debris noted in gullies, indicating debris flows previously.

Potential Hazard to Life: moderate

Potential Hazard to Property: moderate

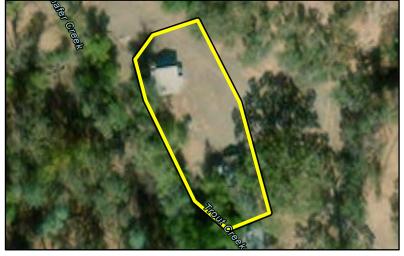
Field Observation Multiple homes located on graded (?) valley bottom below 4 converging steep or *Potential Hazard:* drainages. Berms constructed at base of one channel to divert flow and between another channel and adjacent structures, indicating past flood issues. Blocky debris in drainages.

Potential Hazard to Life: moderate

Potential Hazard to Property: moderate

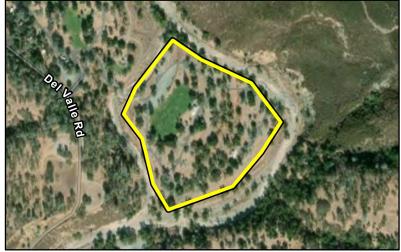
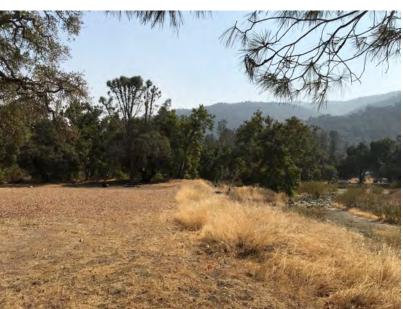
Field Observation Campground located on floodplain terrace, with young geomorphic fetures. *or Potential Hazard:* Main stream channel on northeast side of campground, overflow channl on southwestside of terrace. Restroom buildings and other structures on terrace as well.

Potential Hazard to Life: moderate Potential Hazard to Property: low
